**Naval Surface Warfare Center
Carderock Division**
West Bethesda, Maryland 20817-5700

NSWCCD-TR-97/014

Lead Corrosion in Exhibition Ship Models

by
Dana Wegner,
Curator of Models

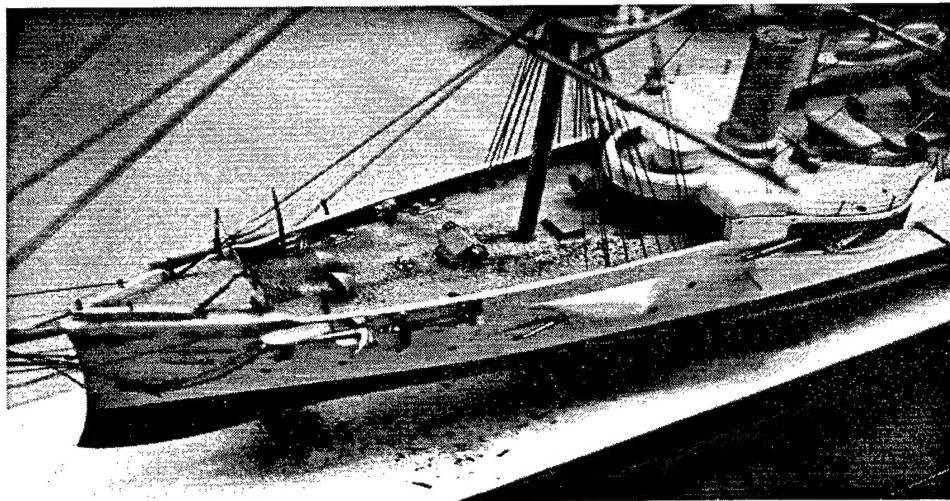
Figure 1. *USS Chicago*

Note: Department of the Navy model catalog #181. Scale 1:96. Built by the Boucher Company, 1922. Photograph taken February 1996 showing advanced state of lead corrosion accrued since 1974. Here, some, but not all, of the lead bitts and ventilators have corroded and littered the forward deck with a gray corrosion byproduct. Portions of the port side anchor have also corroded despite a coating of black paint. Between 1934 and 1994 this model was displayed in a large plywood and plexiglass display case containing a number of other models. Some of the other models showed similar signs of deterioration. NSWCCD Curator's Office photo, Michael Condon.

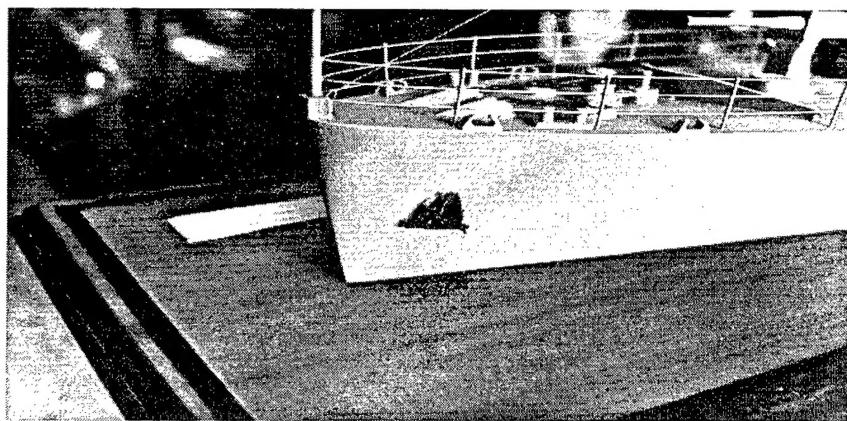
Figure 2. USS PC-461

Note: Navy Department Ship model catalog #587. Scale 1:48. Upgraded drawing room model by the Bureau of Ships, USN, ca. 1940. Photograph taken March 1997. The anchors, the only lead fittings on this model, have been a recurring source of corrosion problems since 1963 when the model was mounted in a glass display case with a mahogany base finished with Fabulon clear coat. The anchor previously had been cleaned and repainted in September 1978. NSWCCD Curator's Office photo, Michael Condon.

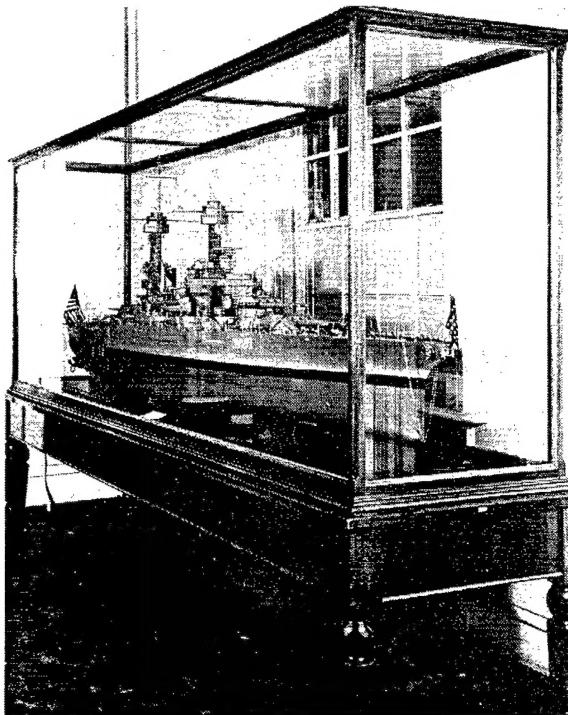
Figure 3. USS California (BB-44)

Note: Navy Department Ship model catalog #151. Scale 1:48. "Builder's model" by the Mare Island Naval Shipyard, ca. 1918. Resplendent in its beautiful contemporary mahogany and glass exhibit case, models such as these did not employ much lead in their construction. They present modern conservators with few lead-related problems. Perhaps the greatest lead-related conservation problem to be expected here is lead-bearing solder which might have been used for attaching parts together. The large glass plates of the exhibit case are set in a rabbet and simply are held in place with slim mahogany strip moldings. This relatively loose-fitted construction doubtless allows the air within the exhibit case to exchange at least once or twice a day, while still protecting the model from most dust and buffering the model from abrupt changes in temperature and humidity. NSWCCD Curator's Office photo.

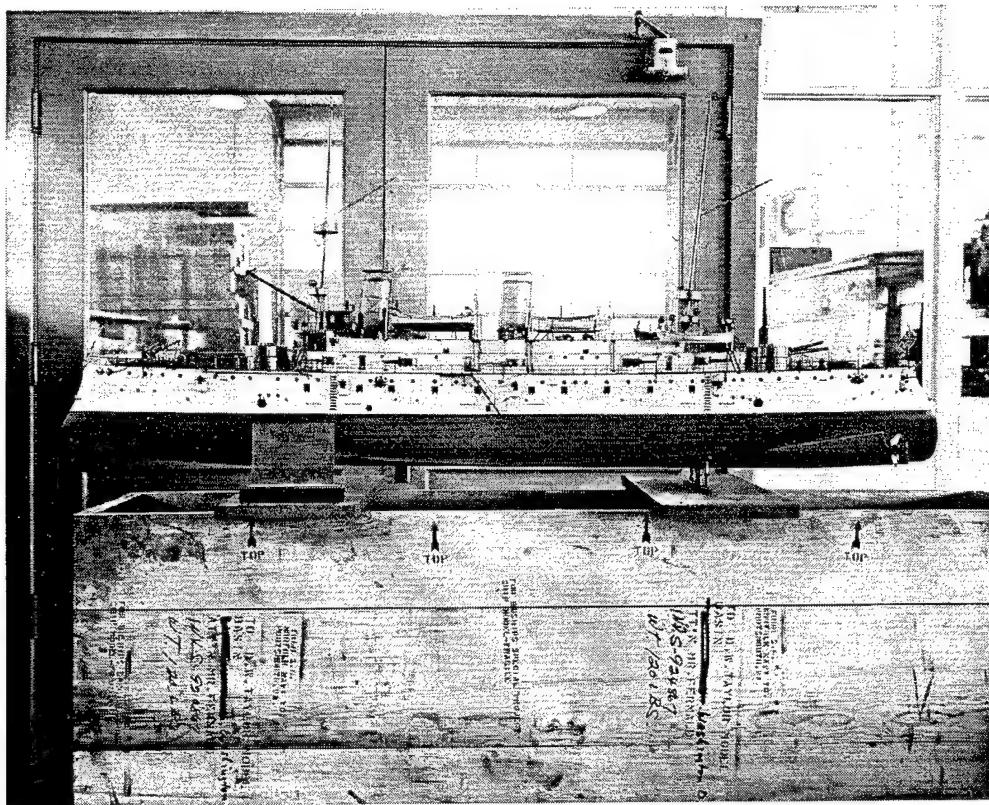
Figure 4. USS Olympia (Cruiser #6)

Note: Navy Department Model catalog #188. Scale 1:48. "Builder's model" by the Bureau of Construction and Repair, USN, ca. 1891. Museums frequently store large artifacts like ship models in wooden crates for extended periods. Today we know that storage crates must be constructed from materials which will not adversely affect the contents. This photograph probably was taken in 1946 and shows the pine crate in which the model resided between 1945 and 1952. U.S. Navy models of this vintage usually were made from a limited list of materials which did not include lead. They have tended to be relatively stable. Here, some features of the model are bright brass, nickel, and copper. NSWCCD Curator's Office photo.
